Date: August 26, 2021
To: Adam Gove, PE, PS
From: Abby Cueva, PE
Subject: Lexington-Springmill Road Safety Study
Copies: Kevin Payne, PE, PS

**COCKLEY ROAD
SIGNAL ALTERNATIVE**

**LEX-SPRINGMILL RD
SAFETY STUDY**

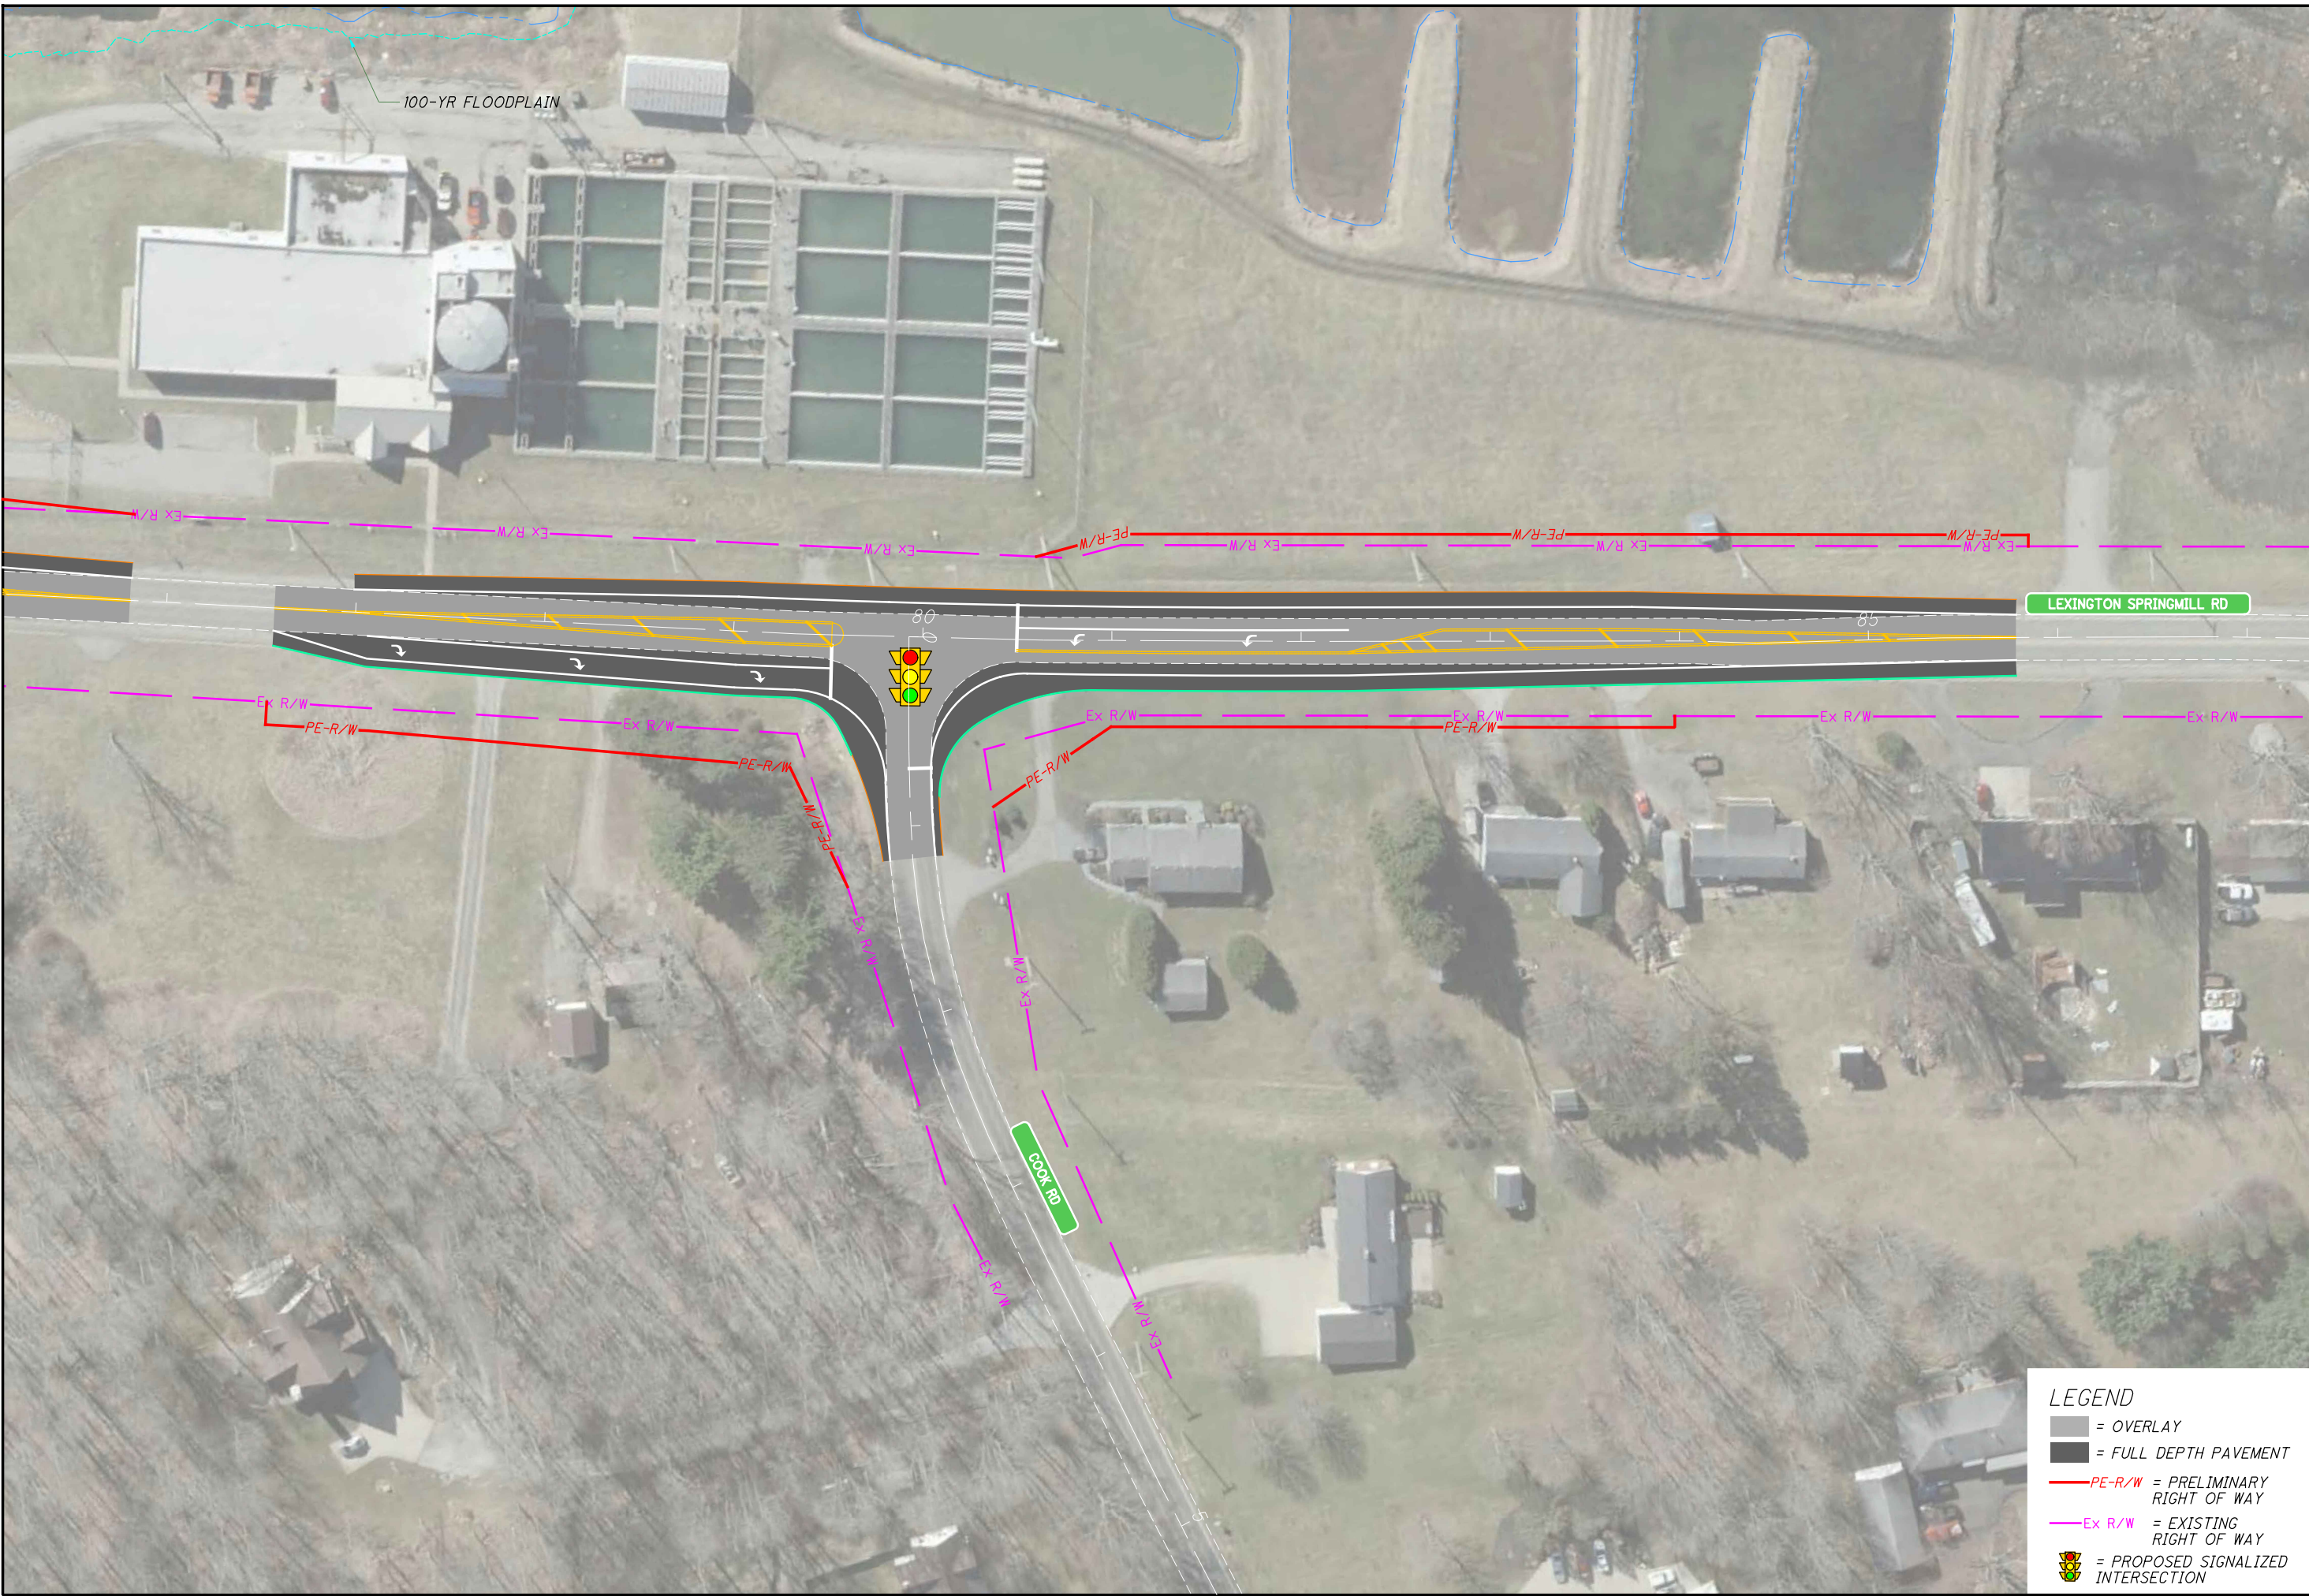
100-YR FLOODPLAIN

LEXINGTON SPRINGMILL RD

A traffic signal is warranted in the Opening Year according to OMUTCD Warrants 1, 2 and 3. HCS7 analysis indicates the signalized Home Road intersection will operate within acceptable levels of delay in the Horizon Year under the existing lane configurations, however, the full safety benefit of signalization would be better achieved with the dedicated NBRT to support the higher turning volumes, particularly when Lexington Springmill is on green. The signalized option was analyzed with and without a SBLT and there was found to be very minimal differences in operations and queue lengths due to the low volume of left turn vehicles, but a safety benefit is seen with the SBLT as summarized below. All individual movements and approaches operate at LOS A or B under the signalized condition in the Horizon Year, while a roundabout operates at LOS A across all movements with single lane approaches.

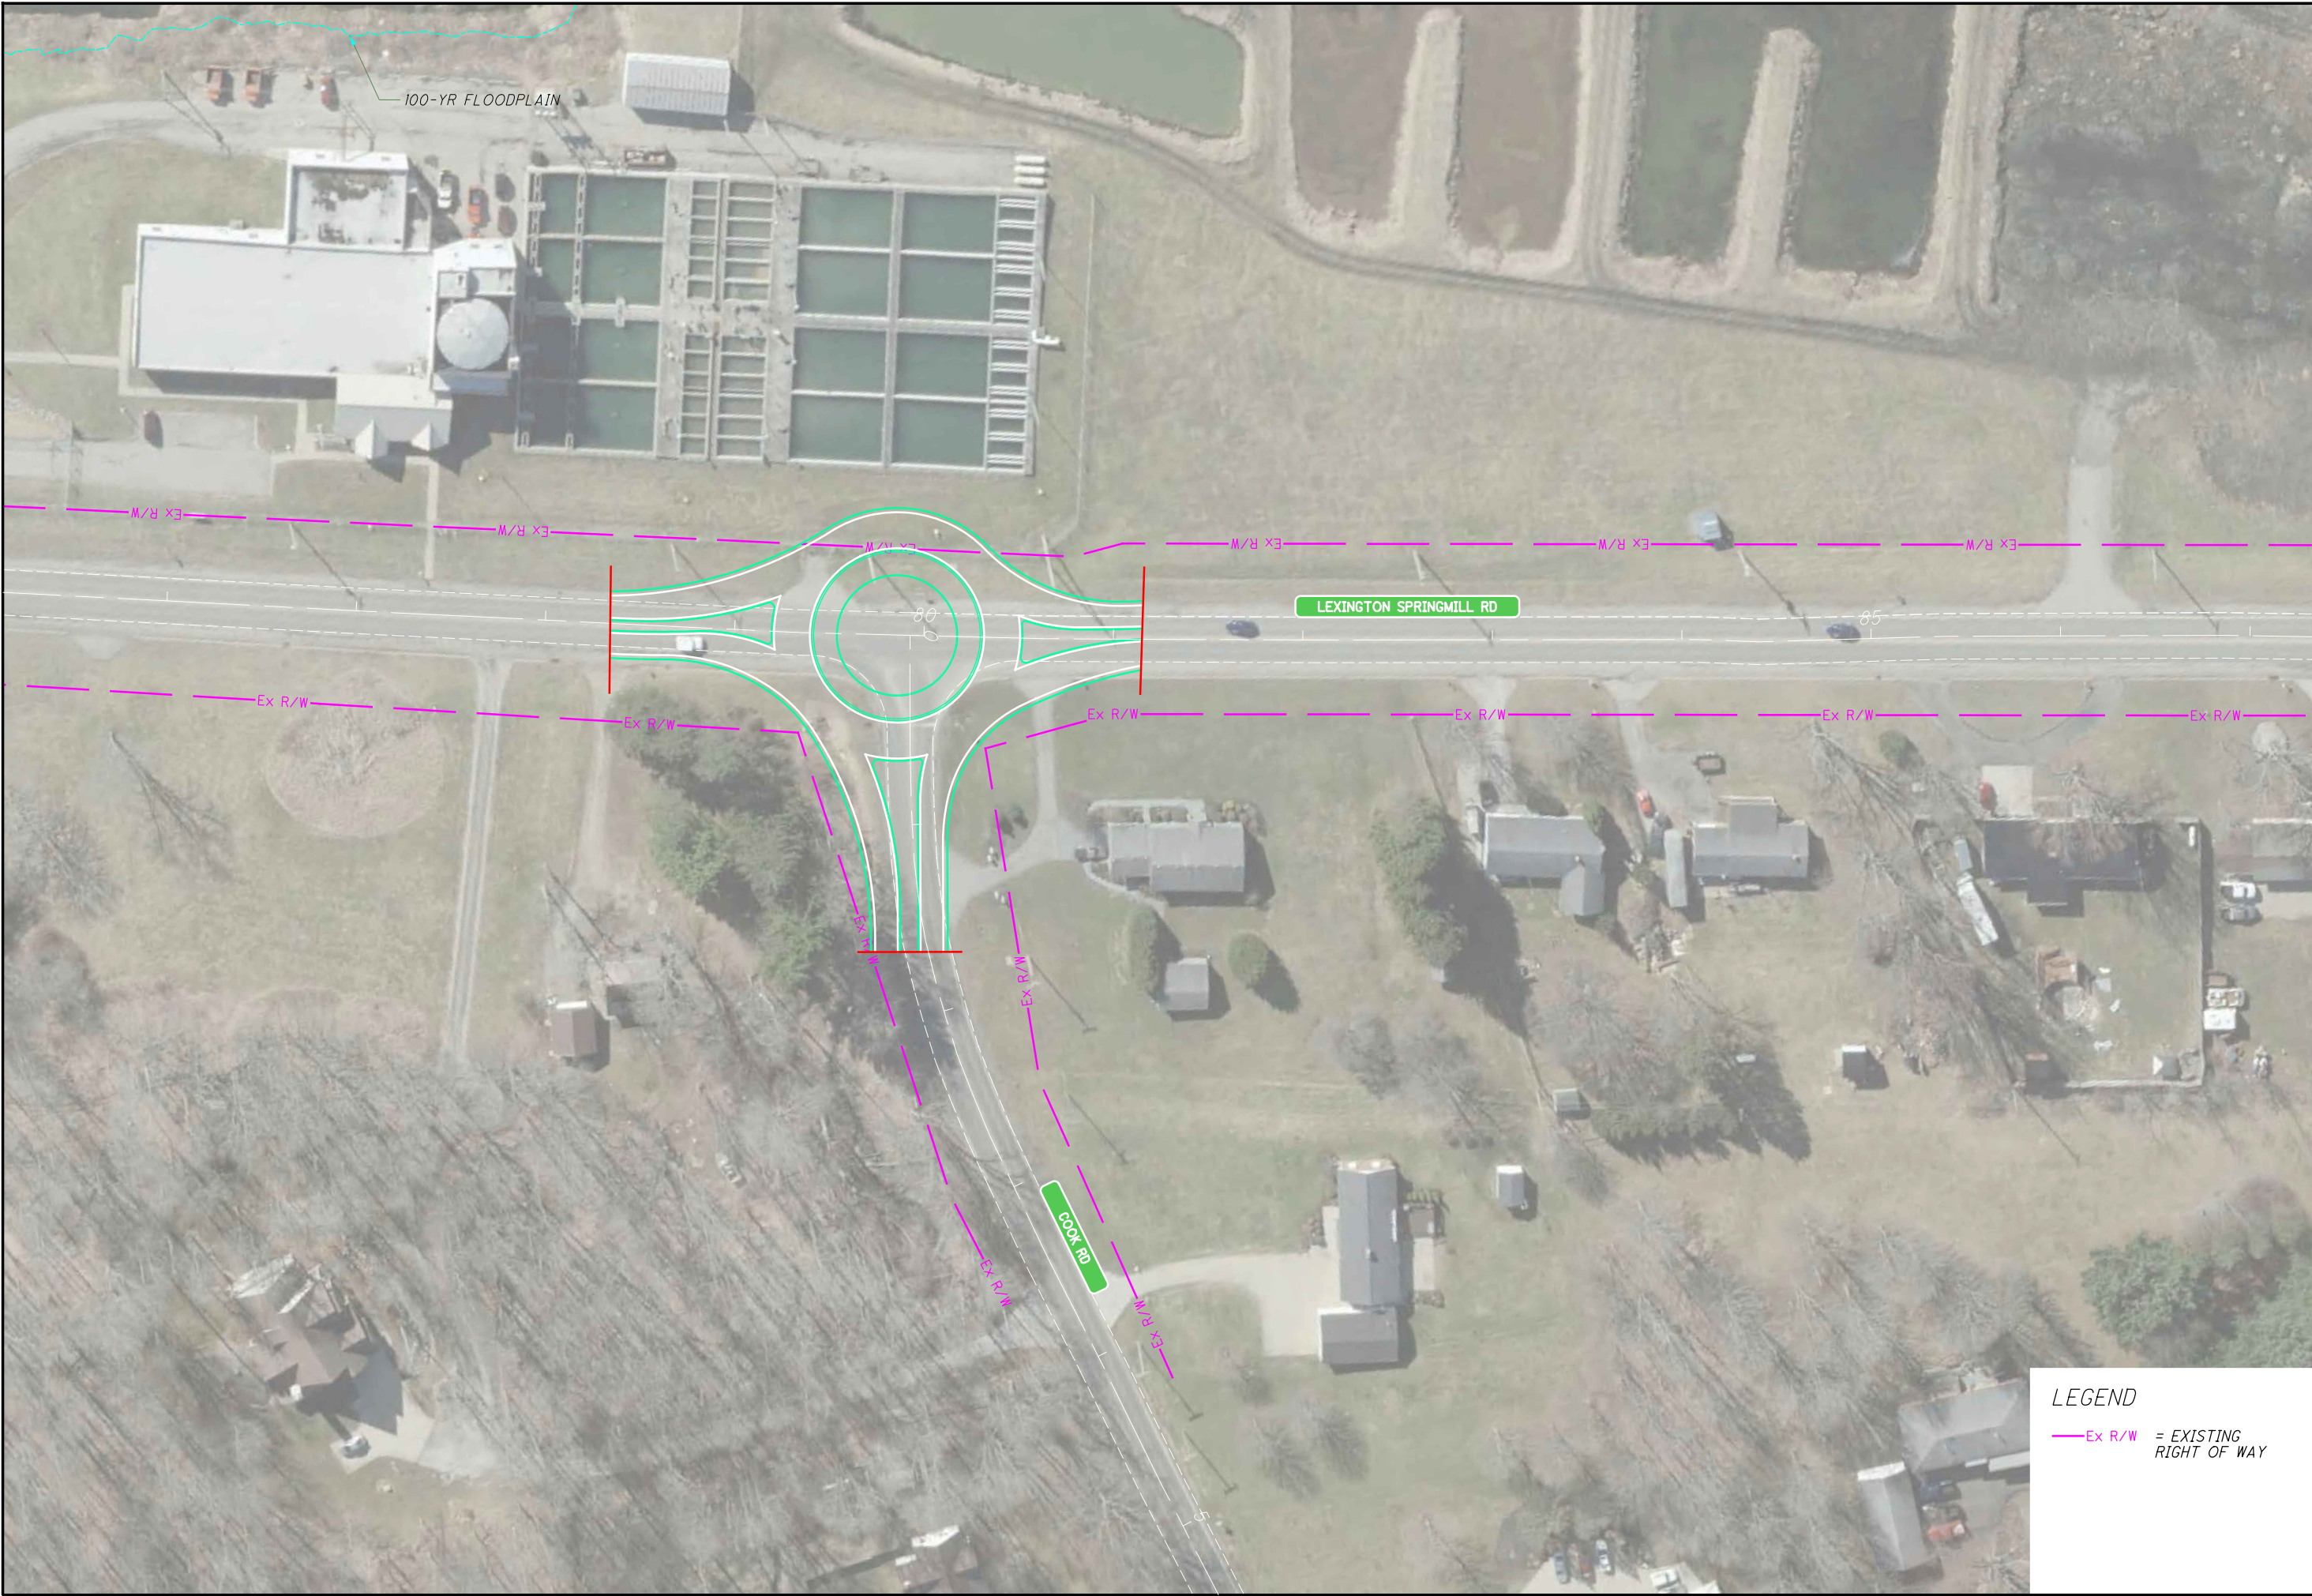
100-YR FLOODPLAIN

LEXINGTON SPRINGMILL RD

It should be noted that the culvert crossing, the stream that runs along the east side of Lexington Springmill, and the Shared Use Path that crosses just north of the intersection will make any improvements here more challenging than some of the other locations. If the stream is impacted (more likely with the widening/signal option), the quality of the stream would need to be assessed to determine the level of permitting based on our impacts. The Shared Use Path will need to be rebuilt and realigned as it approaches the roundabout as shown in the exhibit.

With an average of 5.3 crashes/year, a 31% injury rate, and operational failure approaching for Home Road – the Home Road intersection is the highest priority of the corridor from a safety perspective. The signal alternative and the roundabout alternative both score very favorably, with the B/C for the roundabout at 1.12. With the stream that runs along the east side of Lexington Springmill in this area, the roundabout alternative allows us to reduce impacts to the stream and keep the footprint of the project compact. The Shared Use Path would need to be rebuilt to cross the roundabout safely, but the crossing would be in the low speed area of the roundabout, improving the condition of the existing crossing. The roundabout option gives excellent safety benefit, calms traffic in the non-peak hours without forcing them to stop, allows traffic on Home
